## Cooling Tower Water Distribution Affects Mineral Deposits: Better Distribution = Less Mineral Scale

*By Mario C. Uy, WET International, Inc.*

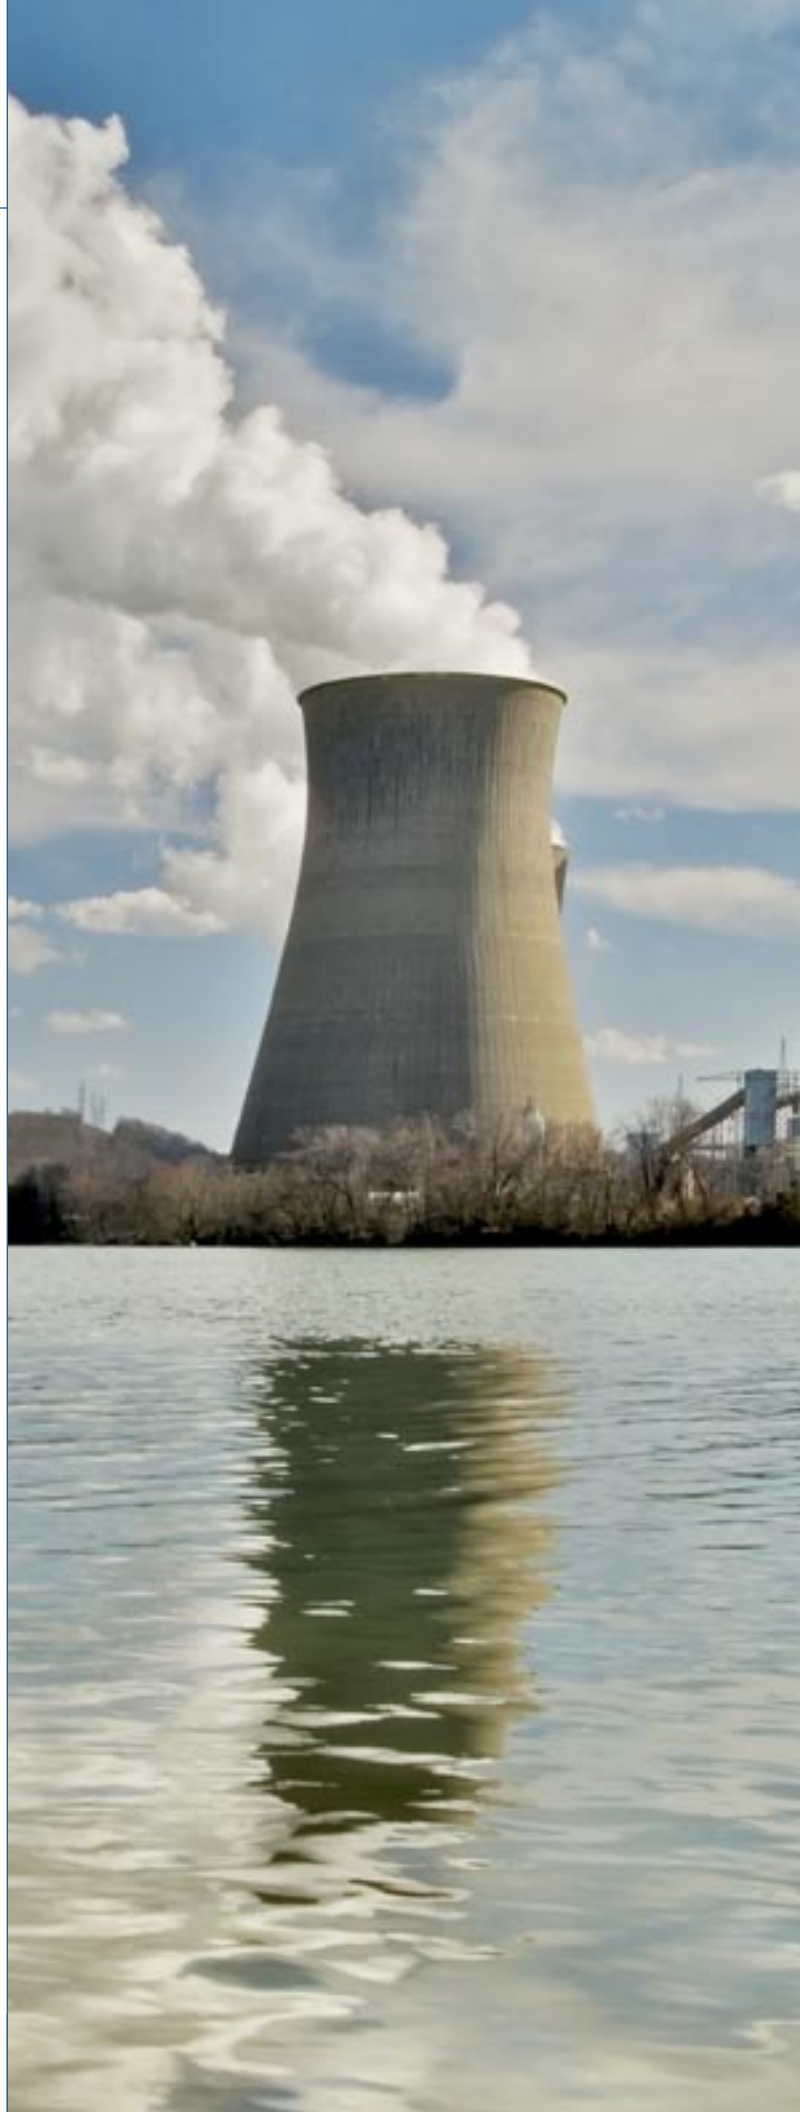
Cooling towers are designed to evaporate water to dissipate the heat in the water to the atmosphere. Typically, cooling water is pumped to the distribution basins where it flows down the cooling tower by gravity, passing through nozzles and what is called the fill, the labyrinth-like packing below the water distribution decks. The fill disperses the flowing water into a larger surface area to enhance evaporation.

Fills can be splash or filming types. Splash-type fills consist of cascading horizontal bars that break up the down-flowing water into droplets. Film-type fills consist of vertical, corrugated-like plates upon which the down-flowing water spreads or film.

The nozzles are designed to disperse the water evenly throughout the fill, while the fill is designed to increase the surface area of water to enhance evaporation. As the water evaporates, it leaves minerals behind, increasing their concentration, and thus increasing their potential to precipitate. With proper water treatment, this precipitation potential can be reduced or prevented.
